**Flood Control Project Maintenance
Levee Inspections**

Fall 2018 Levee Maintenance Deficiency Summary Report

Sutter Maintenance Yard Maintenance Area 0017

Waterway			Bank	Unit Miles
Unit No. 01 Lake County Sutter Maintenance Yard - Middle Creek			Left	3.87
	Spring (March - May)	Summer (June - August)	(September - November) Fall	Winter (December - February)
Unit Maintenance Rating (Fall Only)			U	
Date of Inspection	4/11/2018 - 4/11/2018		10/16/2018 - 10/16/2018	
DWR Inspector	Bob Duffey		Luz Dial	
Accompanied By	Bryan Reniff Sutter Maintenance Yard		Bryan Reniff Sutter Maintenance Yard	
			Robert Duffey DWR

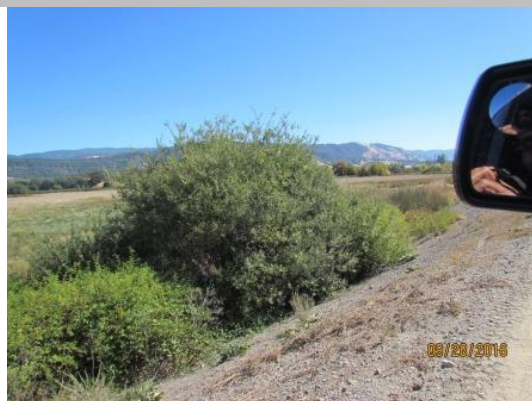
Photo 1 of 1 : FA_2018_MA0017_339_15_20180919_00003.jpg

View of the large bushes limiting visibility and access.

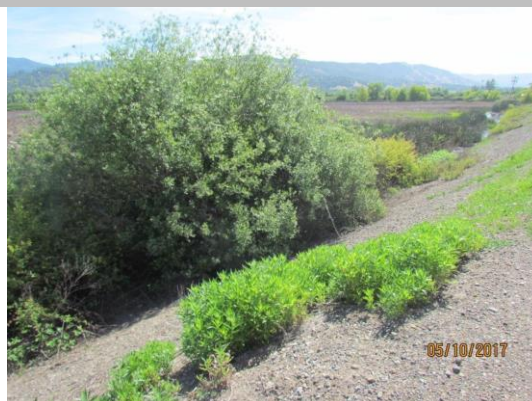
Photo 1 of 1 : FA_2018_MA0017_339_25_20180919_00006.jpg

LM Start	3.84	Rating **	M	Issue No.	25
LM End	3.84	Issue Type +	Ma	Location *	LS
Category	Earthen Levee			GPS Latitude/Longitude	
				Start	End
Item	Trim / Thin Trees			39.144695 °	39.144695 °
				-122.906668 °	-122.906668 °
DWR ID	DWR_MA0017_01_s_2017_25				
Comment Code					
T2 : Thin trees to allow visibility of the ground and room to flood fight.					
Inspector Comment					
Trim the trees along the landside toe.

View of the trees along the landside toe.

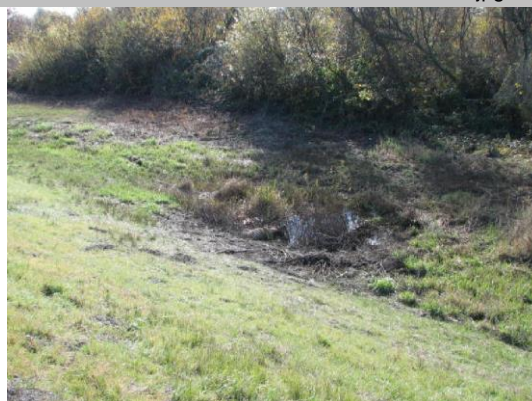
Photo 1 of 3 : UCIP_FA_2018_50814_46849.jpg

Comment Code					
Inspector Comment					
FS_ID:50814 DS_ID:844 EP_NO: 11463 Repair Type: No Action Needed Crossing Status: Found UCIP Comments: 10/19/2016 Crossing appears to be in good ondition. (DWR Sutter Yard- A Freitag)6/14/2016 crossing appears to be in good condition.4/23/2015 No issues with pipe.7/3/2014 Same as last inspection.12/23/2013 Same as last inspection.8/2/2013 New flap gate installed. No other issues with pipe. FIELD_STRUCT_DESC: 24-inch corrugated metal drainage pipe through the levee, 12.4 feet below the crown. Flap gate on the waterside (WS) end. Timber walkway on the landside (LS) slope to a timber walkway to pump house mounted on piles in drainage ditch. (24- inch pipe [HLM 3.99] authorized under Automatic Board Order (ABO) issued as Permit No. 11463, 1975 - Audrey Jones). [Additional Reference(s): DWR Levee Log, 2005. USACE Sacramento O&M Manual 506.2, August 1961, (HLM 3.99)]. FS Date: 11/21/2016 12:09:38 PM

24-inch CMP at outlet on WS toe.

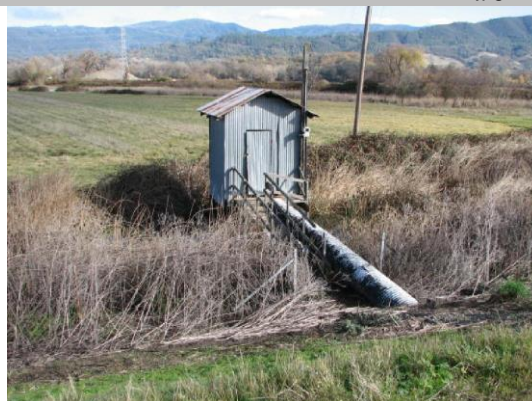
Photo 2 of 3 : UCIP_FA_2018_50814_46848.jpg

Pumphouse on piles at LS toe.

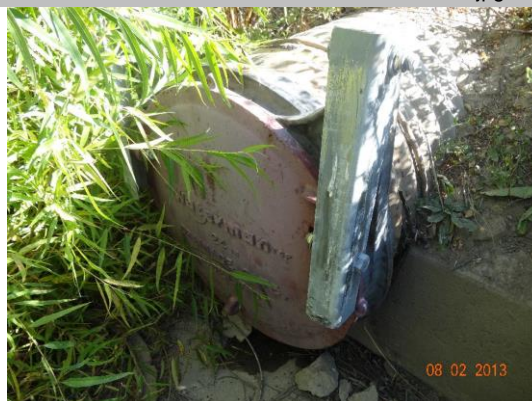
Photo 3 of 3 : UCIP_FA_2018_50814_46850.jpg

New flap gate on WS

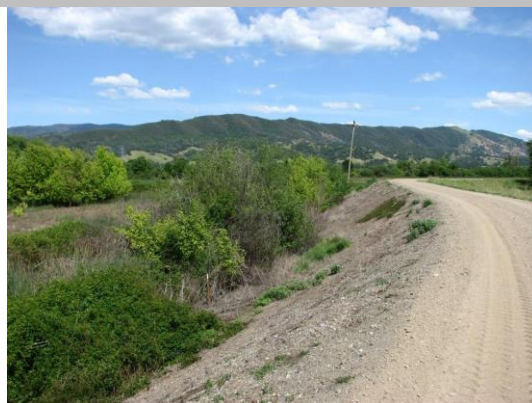
Photo 1 of 1 : FA_2018_MA0017_339_16_20180919_00004.jpg

LM Start	3.96	Rating **	M	Issue No.	16
LM End	4.03	Issue Type +	Ma	Location *	LS
Category	Earthen Levee			GPS Latitude/Longitude	
				Start	End
Item	Vegetation			39.143741 °	39.143585 °
				-122.904705 °	-122.903482 °
DWR ID	DWR_MA0017_01_s_2016_16				
Comment Code					
V2 : Remove the wild growth other than native grasses from the levee slopes.					
Inspector Comment					
Large bushes and brambles growing on wire fence on LS toe limiting visibility and access.

5/2/2016: Remove or trim dense vegetation growing on fence to allow visibility and access to L/S toe.

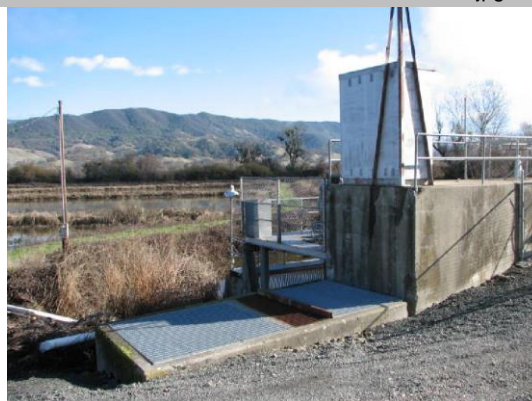
Photo 1 of 3 : UCIP_FA_2018_50815_46853.jpg

Comment Code					
Inspector Comment					
FS_ID:50815 DS_ID:845 EP_NO: 11464 Repair Type: No Action Needed Crossing Status: Found UCIP Comments: 10/27/2017 This structure is inspected annually under the Structure and Channel Summer Inspection (part of the Levee Inspection Program) conducted by the DWR Flood Project Integrity and Inspection Branch (FPIIB). (DWR UCIP - O. Magana) 10/19/2016 Crossing appears to be in good condition. (DWR Sutter Yard- A Freitag)6/14/2016 crossing appears to be in goiid condition.4/23/2015 No issues with pipe.7/3/2014 Same as last inspection.12/23/2013 Same as last inspection.8/2/2013 Same as last inspection. FIELD_STRUCT_DESC: [Bloody Island Pumping Plant] 1 of 2: 42-inch corrugated metal drainage pipe through the levee, 20.2 feet below the crown. Concrete headwall and discharge apron on the waterside (WS) shoulder. Three vertical pump units mounted on a reinforced concrete pump platform in drainage ditch at the landside (LS) toe. Flap gates in concrete discharge well on the LS. Combination flap and slide gate on a gravity pipe from drainage ditch into discharge well. (two 42-inch pipes [HLM 4.18] authorized under Automatic Board Order (ABO) issued as Permit No. 11464, 1975 - Lake County). [Additional Reference(s): DWR Levee Log, 2005. USACE Sacramento O&M Manual 506.2, August 1961, (HLM 4.18)]. FS Date: 11/21/2016 12:10:29 PM

Pumping Plant on LS shoulder.

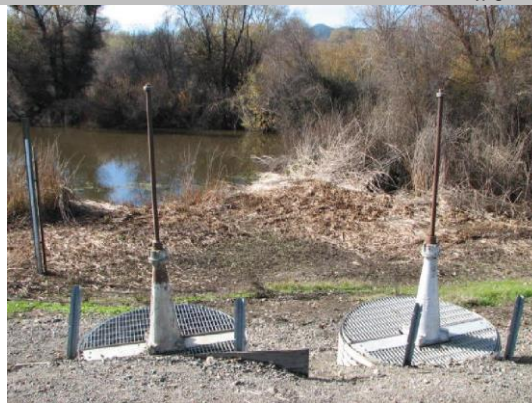
Photo 2 of 3 : UCIP_FA_2018_50815_46852.jpg

Slide gates in CMP risers on WS shoulder.

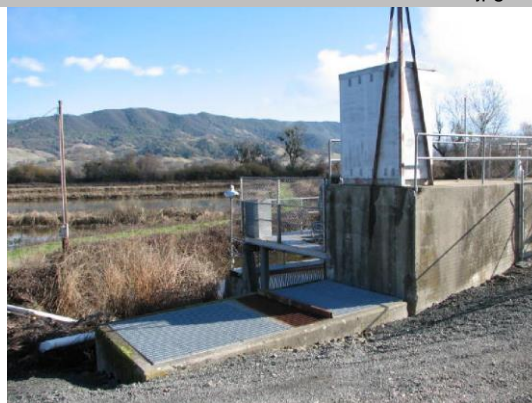
Photo 1 of 3 : UCIP_FA_2018_50816_46856.jpg

Comment Code					
Inspector Comment					
FS_ID:50816 DS_ID:852 EP_NO: 11464 Repair Type: No Action Needed Crossing Status: Found UCIP Comments: 10/27/2017 This structure is inspected annually under the Structure and Channel Summer Inspection (part of the Levee Inspection Program) conducted by the DWR Flood Project Integrity and Inspection Branch (FPIIB). (DWR UCIP - O. Magana) 10/19/2016 Crossing appears to be in good condition. (DWR Sutter Yard- A Freitag)6/14/2016 crossing appears to be in goiid condition.4/23/2015 No issues with pipe.7/3/2014 Same as last inspection.12/23/2013 Same as last inspection.8/2/2013 Same as last inspection. FIELD_STRUCT_DESC: [Bloody Island Pumping Plant] 2 of 2: 42-inch corrugated metal drainage pipe through the levee, 14.6 feet below the crown. Concrete headwall and discharge apron on the waterside (WS) shoulder. Three vertical pump units mounted on a reinforced concrete pump platform in drainage ditch at the landside (LS) toe. Flap gates in concrete discharge well on the LS. Combination flap and slide gate on a gravity pipe from drainage ditch into discharge well. (two 42-inch pipes [HLM 4.18] authorized under Automatic Board Order (ABO) issued as Permit No. 11464, 1975 - Lake County). [Additional Reference(s): DWR Levee Log, 2005. USACE Sacramento O&M Manual 506.2, August 1961, (HLM 4.18)]. FS Date: 11/21/2016 12:11:01 PM

Pumping plant on LS shoulder.

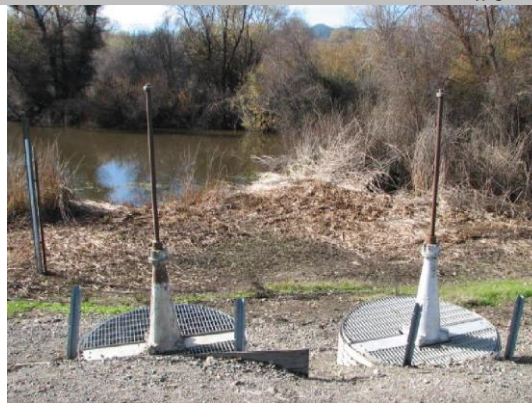
Photo 2 of 3 : UCIP_FA_2018_50816_46855.jpg

Slide gate in CMP riser on WS shoulder.

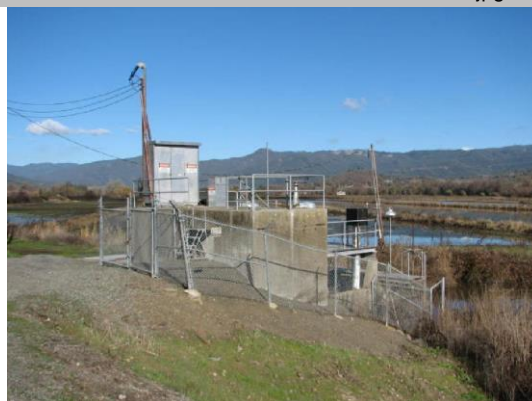
Photo 3 of 3 : UCIP_FA_2018_50816_46854.jpg

Pumping plant on LS shoulder.

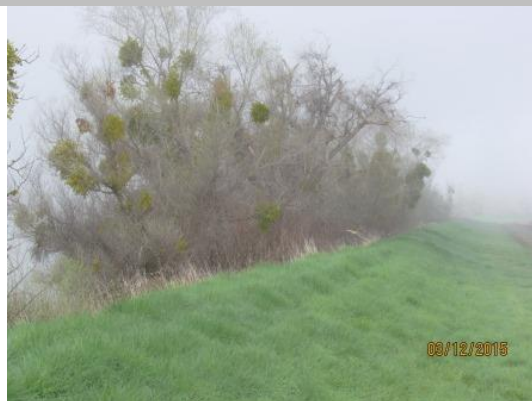
Photo 1 of 2 : FA_2018_MA0017_339_2_20180919_00001.jpg

LM Start	4.16	Rating **	U	Issue No.	2
LM End	7.10	Issue Type +	Ma	Location *	WS
Category	Earthen Levee			GPS Latitude/Longitude	
				Start	End
Item	Trim / Thin Trees			39.141894 °	39.120609 °
				-122.902201 °	-122.887166 °
DWR ID	DWR_MA0017_01_s_2012_2				
Comment Code					
T2 : Thin trees to allow visibility of the ground and room to flood fight.					
Inspector Comment					
Trees and limbs are completely obstructing visibility on crown and WS. Crown is too narrow to drive and overgrown with weeds, brush, and trees. Road follows LS toe.

View of the trees along the waterside slope and toe.

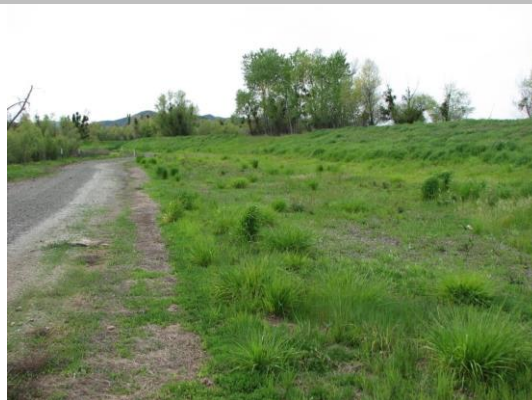
Photo 2 of 2 : FA_2018_MA0017_339_2_20180919_00002.jpg

Photo taken at LM 6.41 looking west showing overgrown LS slope of levee at right and toe road at left. Note trees obstructing visibility and access at levee crown. Crown is +/- 5 feet wide, and impassible to vehicles due to vegetation, and in some places, to pedestrians.
4/19/2016

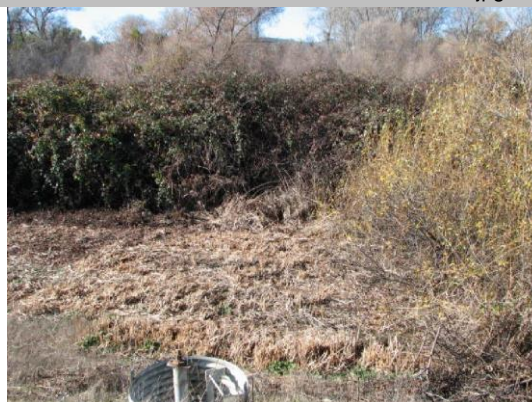
Photo 1 of 2 : UCIP_FA_2018_50817_46858.jpg

Comment Code						
Inspector Comment						
FS_ID:50817						
DS_ID:846						
EP_NO: 11462						
Repair Type: Non-Urgent						
Crossing Status: Found						
UCIP Comments: 10/19/2016 No riser lid or slide gate wheel. (DWR Sutter Yard- A Freitag)6/14/2016 No riser lid and no wheel to operate screw gate.4/23/2015 Still no lid on riser and wheel to operate slide gate is missing.7/3/2014 Same as last inspection.12/23/2013 Same as last inspection.8/2/2013 Same as last inspection.12/13/2012 No lid on riser-may or may not be an issue.						
FIELD_STRUCT_DESC: 24-inch corrugated metal drainage pipe through the levee, 19 feet below the crown. Slide gate in 36-inch corrugated metal pipe (CMP) riser on the waterside (WS) slope. (Automatic Board Order (ABO) issued as Permit No. 11462, 1975 - Hobson) [Additional Reference(s): DWR Levee Log, 2005].						
FS Date: 11/21/2016 12:11:29 PM

Slide gate in CMP riser on WS slope.

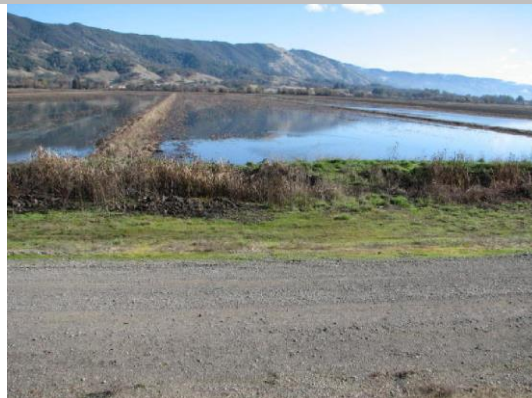
Photo 2 of 2 : UCIP_FA_2018_50817_46857.jpg

LS toe at approximate location of pipe inlet.

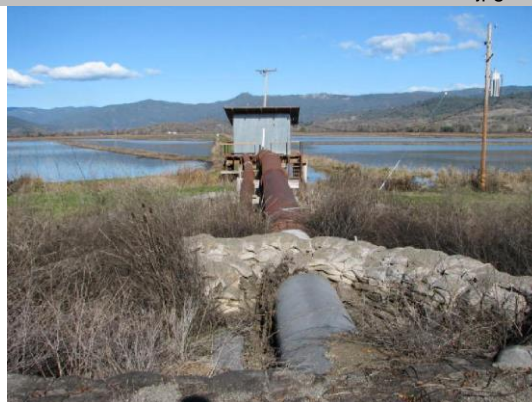
Photo 1 of 2 : UCIP_FA_2018_50818_46860.jpg

Comment Code					
Inspector Comment					
FS_ID:50818					
DS_ID:847					
EP_NO: 11469					
Repair Type: Non-Urgent					
Crossing Status: Found					
UCIP Comments: 10/19/2016 Sack ring still in place. (DWR Sutter Yard- A Freitag)6/14/2016 Sack ring is still built up underneath the pipes.4/23/2015 Sack ring is still built up underneath the pipes.7/3/2014 Same as last inspection.12/23/2013 Same as last inspection.8/2/2013 Same as last inspection.12/13/2012 flood fight materials-ring levees around both LS and WS slopes at pipe crossing. This may or may not be an issue.					
FIELD_STRUCT_DESC: 1 of 2: 16-inch steel drainage pipe through the levee, 5 feet below the crown. Drainage pumping plant on the landside (LS). Flap gate on the waterside (WS) end. (one 16-inch and one 36-inch pipes [HLM 5.43] authorized under Automatic Board Order (ABO) issued as Permit No. 11469, 1975 - RD 2070). [Additional Reference(s): DWR Levee Log, 2005. USACE Sacramento O&M Manual 506.3, August 1961, (HLM 5.43)].

Pumping plant, pipes, and ring levees on LS toe.

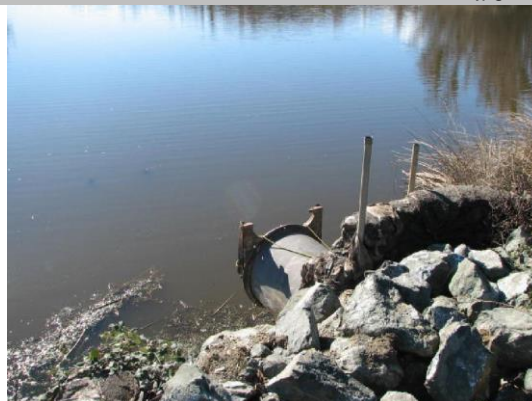
Photo 2 of 2 : UCIP_FA_2018_50819_46863.jpg

Pipe, flap gate, air vent, and sandbags on WS slope.

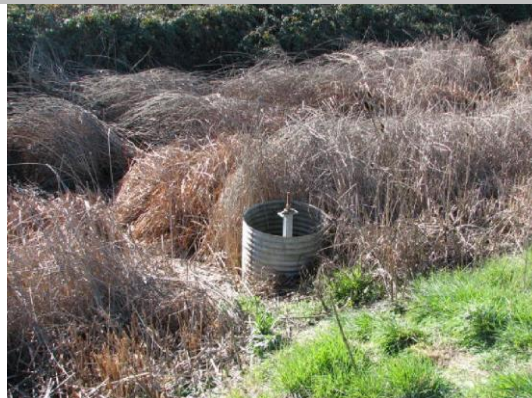
Photo 1 of 2 : UCIP_FA_2018_50820_46866.jpg

Comment Code					
Inspector Comment					
FS_ID:50820 DS_ID:848 EP_NO: 11457 Repair Type: Non-Urgent Crossing Status: Found UCIP Comments: 10/19/2016 No riser lid or slide gate wheel. (DWR Sutter Yard- AFreitag)6/14/2016 No riser lid and no wheel to operate screw gate.4/23/2015 No cover on riser and no wheel to operate gate.7/3/2014 Same as last inspection.12/23/2013 Same as last inspection.8/2/2013 Handle to operate gate was in place but still no cover on riser.12/13/2012 No cover on CMP riser and no handle for actuating gate. This may or may not be an issue. FIELD_STRUCT_DESC: 24-inch drainage pipe under patrol road and through the levee, 13.5 feet below the crown. Concrete "U" shaped headwall on the landside (LS) end. Slide gate in 36-inch corrugated metal pipe (CMP) riser on the waterside (WS) slope. Riser unit is mounted on concrete base. (24-inch pipe [HLM 5.87] authorized under Automatic Board Order (ABO) issued as Permit No. 11457, 1975 - Crawford). [Additional Reference(s): DWR Levee Log, 2005. USACE Sacramento O&M Manual 506.3, August 1961, (HLM 5.87)]. FS Date: 11/21/2016 12:12:57 PM

36-inch CMP riser and slide gate on WS slope.

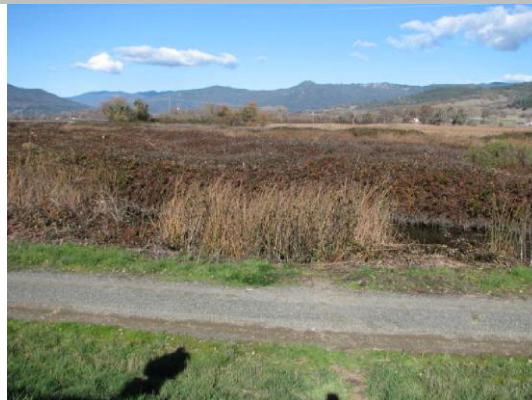
Photo 2 of 2 : UCIP_FA_2018_50820_46865.jpg

Approximate location of inlet on LS toe (not visible).

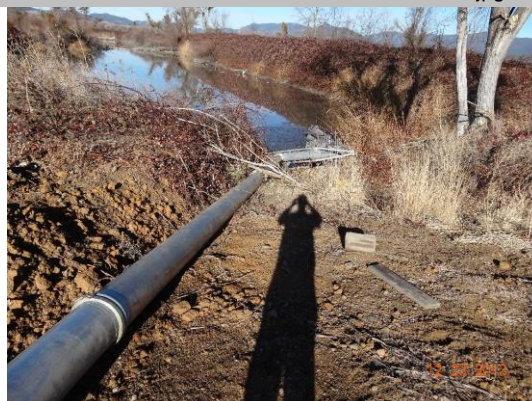
Photo 1 of 1 : UCIP_FA_2018_50823_47920.jpg

Comment Code					
Inspector Comment					
FS_ID:50823 DS_ID:20589 EP_NO: N/A Repair Type: Non-Urgent Crossing Status: Found UCIP Comments: 10/19/2016 12" pipe not present for this inspection. (DWR Sutter Yard- A Freitag)6/14/2106 12" pipe was removed from the roadway. Portable pump was not found on the bank this time.4/23/2015 12" pipe still ran over the top of roadway. 7/3/2014 Same as last inspection.12/23/2013 No signs of 12" pvc. Portable tow-pump was lowered down on waterside with 12" pipe ran over roadway.8/2/2013 Same as last inspection.12/13/2012 No permit for crossing. FIELD_STRUCT_DESC: *REMOVED* 12-inch high-density polyethylene (HDPE) drainage pipe through the levee, 1.5 feet below the crown. No permit has been identified since crossing was field discovered in 2012. FS Date: 11/21/2016 12:14:52 PM

Portable pump on WS and temporary piping over roadway

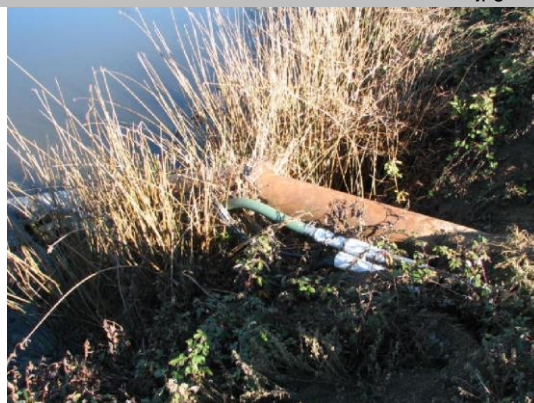
Photo 1 of 3 : UCIP_FA_2018_53325_46878.jpg

Comment Code						
Inspector Comment						
FS_ID:53325 DS_ID:20587 EP_NO: N/A Repair Type: Urgent Crossing Status: Found UCIP Comments: 9/6/18 Same as last inspection; WS erosion is still present so the crossing remains Urgent (D. Sanoski - DWR UCIP).10/19/2016 WS erosion still present. (DWR Sutter Yard- AFreitag)6/14/2016 WS erosoin is still present. (DWR Sutter Yard - afreitag)4/23/2015 Erosion on WS shoulder is still present. (DWR Sutter Yard - afreitag)7/3/2014 Same as last inspection. (DWR Sutter Yard - afreitag)12/23/2013 Same as last inspection. (DWR Sutter Yard - afreitag)8/2/2013 Erosion on WS shoulder above pipes. (DWR Sutter Yard - afreitag)12/13/2012 No permit for this crossing. This is a primer line, used to fill up main pipe before its pump is turned on (Permit No. 11467). (DWR UCIP - wwylie) FIELD_STRUCT_DESC: 4-inch polyvinyl chloride (PVC) conduit of an unknown purpose through the levee, 2 feet below the crown, with plastic pipe running through it to pump on the landside (LS). No permit has been identified since crossing was field discovered in 2012. FS Date: 9/6/2018 11:26:00 AM

4-inch pvc pipe with green flexible pipe running through it on WS shoulder.

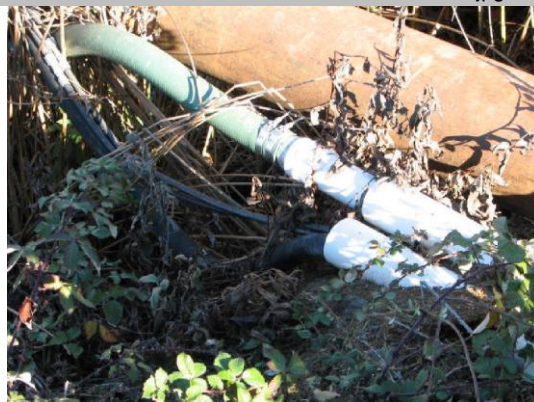
Photo 2 of 3 : UCIP_FA_2018_53325_46877.jpg

4-inch pvc pipe with green flexible pipe running through it on WS shoulder.

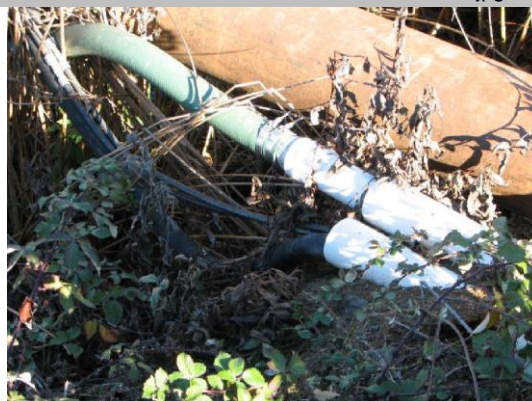
Photo 1 of 3 : UCIP_FA_2018_53324_46874.jpg

Comment Code					
Inspector Comment					
FS_ID:53324 DS_ID:20588 EP_NO: N/A Repair Type: Urgent Crossing Status: Found UCIP Comments: 9/6/18 Same as last inspection; WS erosion is still present so the crossing remains Urgent (D. Sanoski - DWR UCIP).10/19/2016 WS erosion still present. (DWR Sutter Yard-afreitag)6/14/2016 WS erosion is still present. (DWR Sutter Yard -afreitag)4/23/2015 Erosion still present on WS shoulder. (DWR Sutter Yard -afreitag)7/3/2014 Same as last inspection. (DWR Sutter Yard -afreitag)12/23/2013 Same as last inspection. (DWR Sutter Yard -afreitag)8/2/2013 Erosion on WS shoulder above pipes. (DWR Sutter Yard -afreitag)12/13/2012 No permit for this crossing. It is unclear what these hydraulic lines are for, but it is probably the works for a hydraulic butterfly valve at the outlet. (DWR UCIP - wwylie) FIELD_STRUCT_DESC: 4-inch polyvinyl chloride (PVC) conduit of an unknown purpose through the levee, 2 feet below the crown, with hydraulic lines running through it to pump on the landside (LS) shoulder. No permit has been identified since crossing was field discovered in 2012. FS Date: 9/6/2018 11:29:00 AM

Pipe and hydraulic lines on WS shoulder.

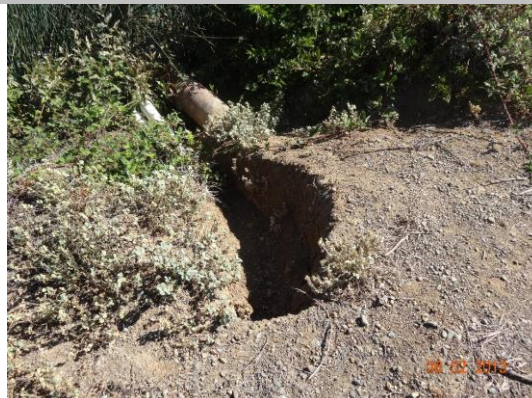
Photo 3 of 3 : UCIP_FA_2018_53324_46875.jpg

Comment Code						
Inspector Comment						
FS_ID:53324 DS_ID:20588 EP_NO: N/A Repair Type: Urgent Crossing Status: Found UCIP Comments: 9/6/18 Same as last inspection; WS erosion is still present so the crossing remains Urgent (D. Sanoski - DWR UCIP).10/19/2016 WS erosion still present. (DWR Sutter Yard-afreitag)6/14/2016 WS erosion is still present. (DWR Sutter Yard -afreitag)4/23/2015 Erosion still present on WS shoulder. (DWR Sutter Yard - afreitag)7/3/2014 Same as last inspection. (DWR Sutter Yard -afreitag)12/23/2013 Same as last inspection. (DWR Sutter Yard -afreitag)8/2/2013 Erosion on WS shoulder above pipes. (DWR Sutter Yard - afreitag)12/13/2012 No permit for this crossing. It is unclear what these hydraulic lines are for, but it is probably the works for a hydraulic butterfly valve at the outlet. (DWR UCIP - wwylie) FIELD_STRUCT_DESC: 4-inch polyvinyl chloride (PVC) conduit of an unknown purpose through the levee, 2 feet below the crown, with hydraulic lines running through it to pump on the landside (LS) shoulder. No permit has been identified since crossing was field discovered in 2012. FS Date: 9/6/2018 11:29:00 AM

Erosion on WS shoulder

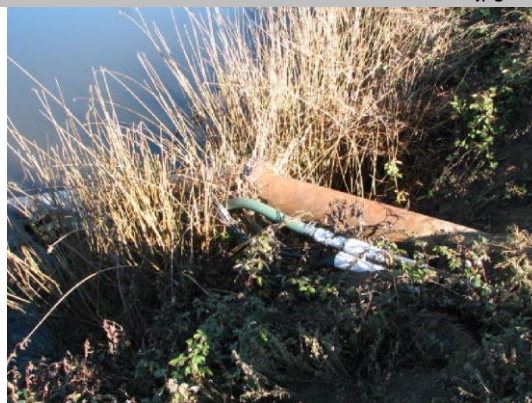
Photo 1 of 3 : UCIP_FA_2018_53323_46882.jpg

Comment Code						
Inspector Comment						
FS_ID:53323 DS_ID:850 EP_NO: 11467 Repair Type: Urgent Crossing Status: Found UCIP Comments: 9/6/18 Same as last inspection; WS erosion is still present so the crossing remains Urgent (D. Sanoski - DWR UCIP).10/19/2016 WS erosion still present. (DWR Sutter Yard - A Freitag)6/14/2016 WS erosion is still present. (DWR Sutter Yard - A Freitag)4/23/2015 Same as last inspection. (DWR Sutter Yard - A Freitag)7/3/2014 Same as last inspection. (DWR Sutter Yard - A Freitag)12/23/2013 Same as last inspection. (DWR Sutter Yard - A Freitag)8/2/2013 Same as last inspection. (DWR Sutter Yard - A Freitag)12/13/2012 This pipe and appurtances do not match what was described in the permit (PN: 11467). Does not appear to be in compliance with board regulations. (DWR UCIP - wwylye) FIELD_STRUCT_DESC: 12-inch steel drainage pipe through the levee, 2 feet below the crown. Butterfly valve on the landside (LS) shoulder. Pump and electrical panel, along with multiple valves and appurtenances, on the LS shoulder. (12-inch pipe [HLM 6.11] authorized under Automatic Board Order (ABO) issued as Permit No. 11467, 1975 - B. F. Modglin[Additional Reference(s): DWR Levee Log, 2005. USACE Sacramento O&M Manual 506.3, 1967, (HLM 6.11)]. FS Date: 9/6/2018 10:48:00 AM

12-inch pipe and appurtances on WS shoulder.

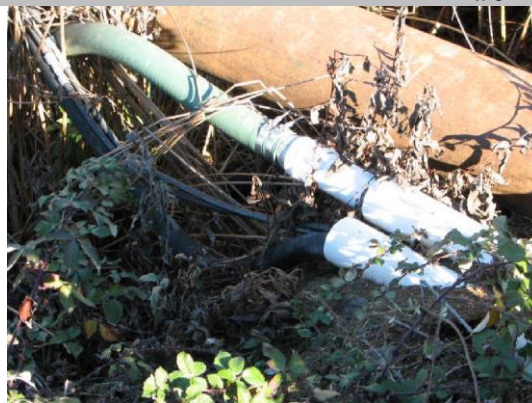
Photo 2 of 3 : UCIP_FA_2018_53323_46881.jpg

12-inch pipe and appurtances on WS shoulder.

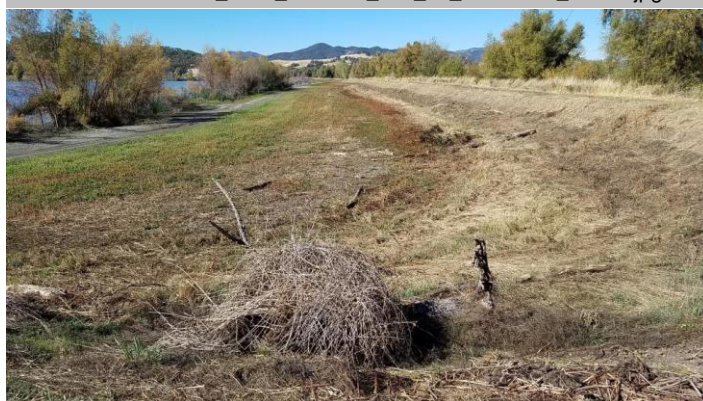
Photo 1 of 2 : FA_2018_MA0017_339_23_20181022_00046.jpg

LM Start	6.03	Rating **	U	Issue No.	23
LM End	7.28	Issue Type +	Ob	Location *	LS
Category	Earthen Levee			GPS Latitude/Longitude	
				Start	End
Item	Seepage / Sandboils			39.126045 °	39.118727 °
				-122.883828 °	-122.884842 °
DWR ID	DWR_MA0017_01_s_2017_23				
Comment Code					
Inspector Comment					
The water receded from the levee.

View of the water away from the levee slope. Fall 2018

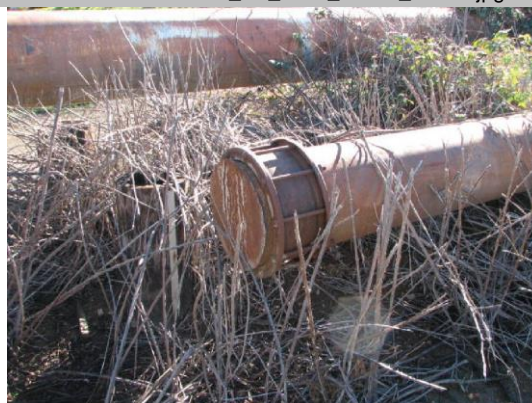
Photo 2 of 2 : UCIP_FA_2018_50827_46883.jpg

Steel plate welded over end of pipe at LS toe.
